Re: Riverbank Pipe Observations
Willamette Cove Upland Facility
Portland, Oregon
ECSE No. 271
1056-03

Riverbank Pipe Observations
Port of Portland / Metro
Willamette Cove Upland Facility - Portland, Oregon

Project Name: Willamette Cove Upland Facility
Project Number: 1056-03

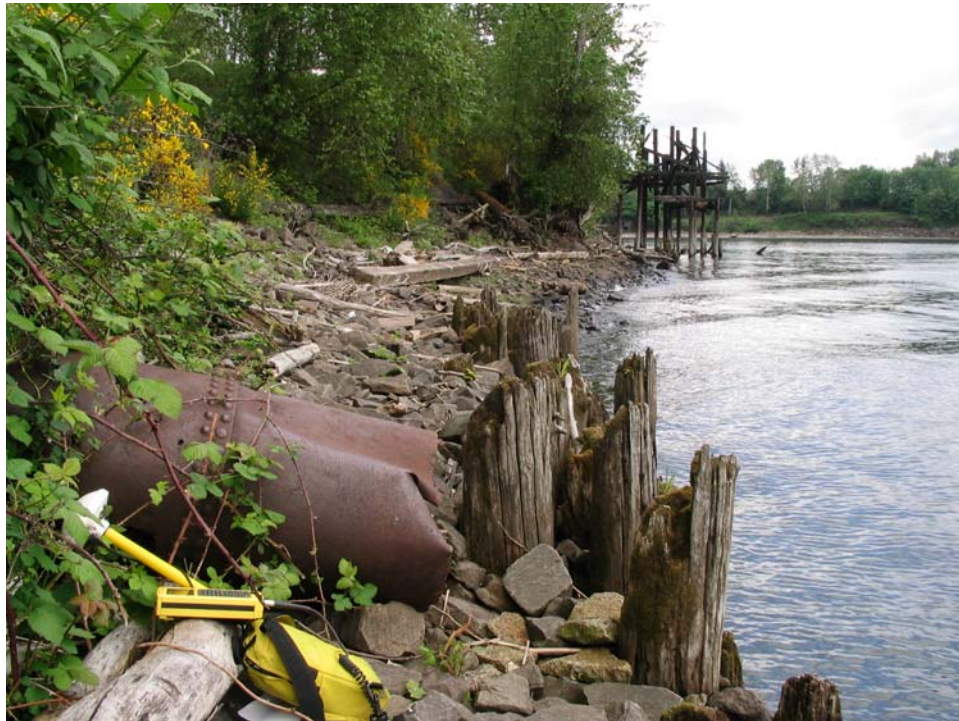
Metal sleeve with concrete plug – apparent debris on rip-rap.
Rivets indicate this is not a pipe.

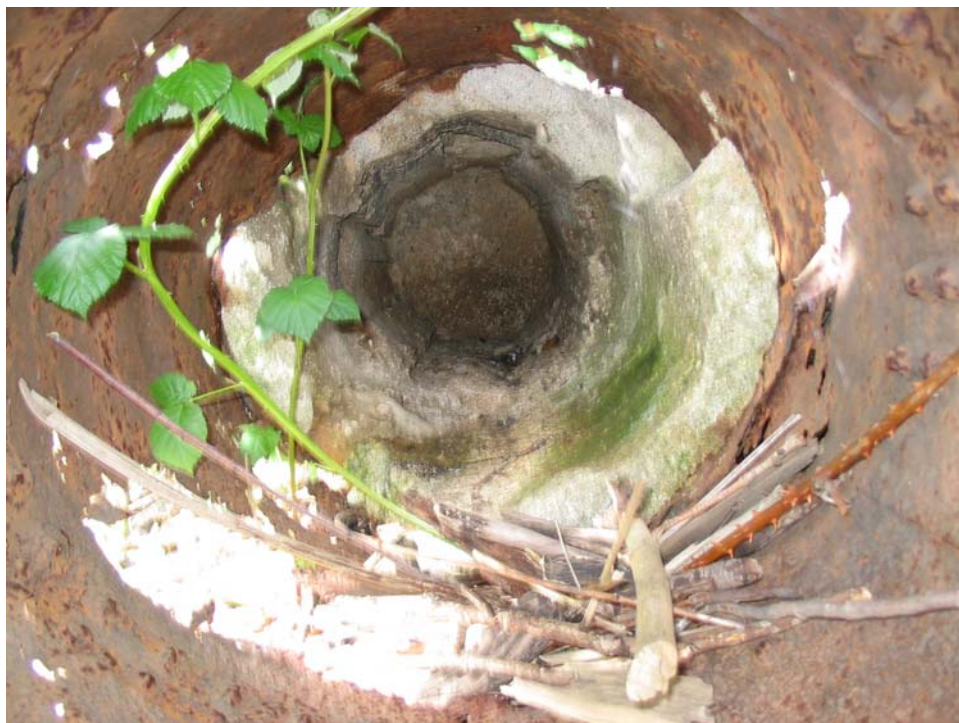
Interior of metal sleeve: concrete plug.

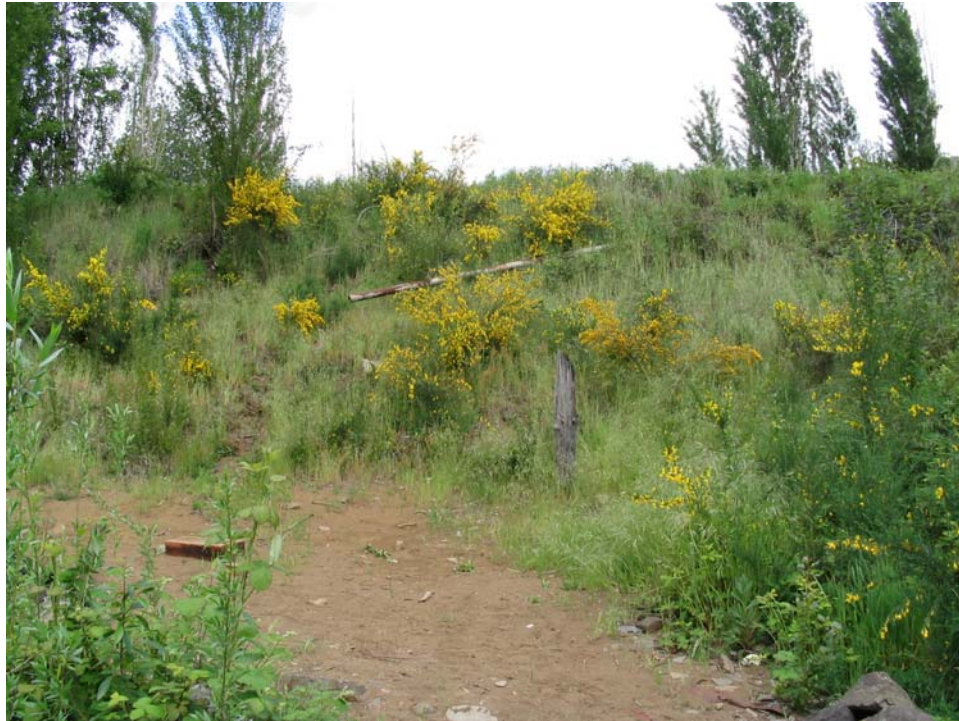
Four-inch diameter steel pipe protruding parallel to riverbank

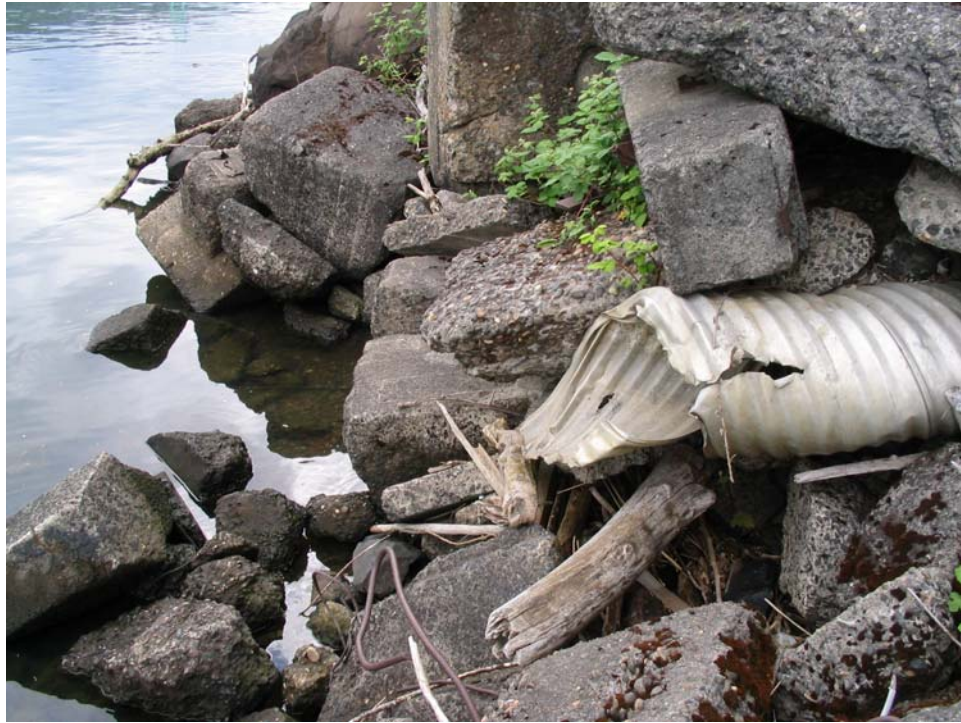
Two-foot diameter corrugated steel pipe at reported location for potential outfall WR-189. Did not appear to be an active outfall.

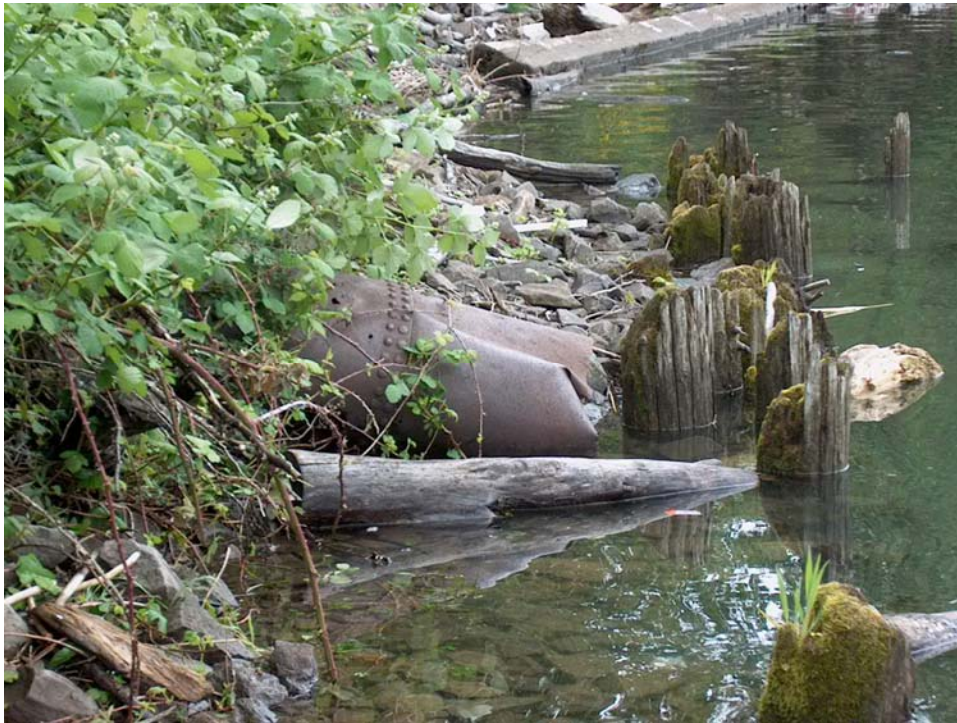
Metal sleeve surrounding concrete interior.

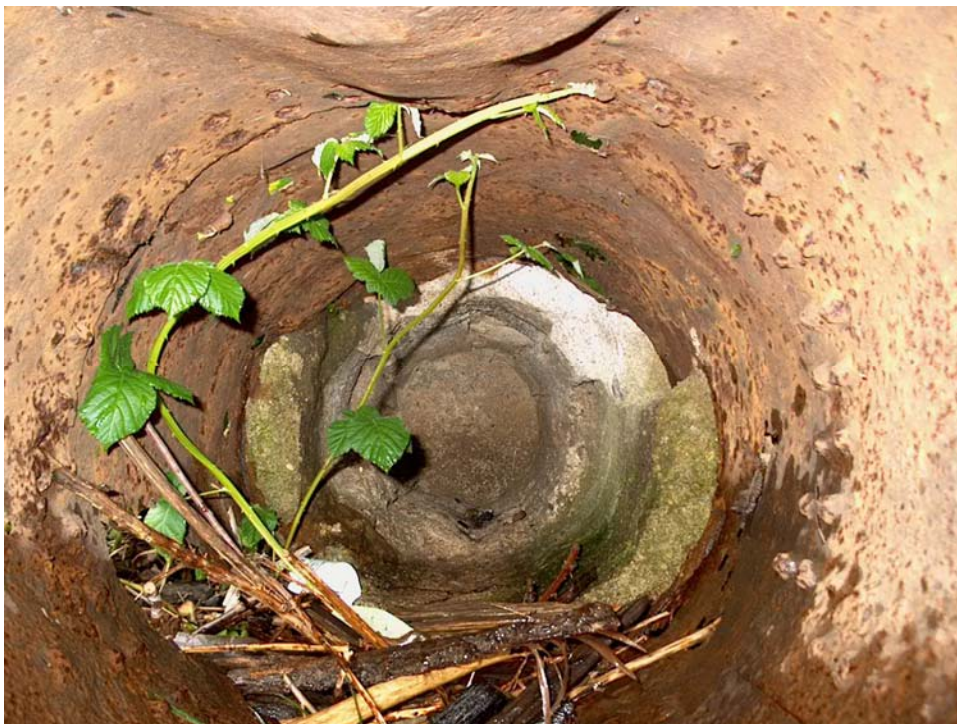
Concrete interior and plug.

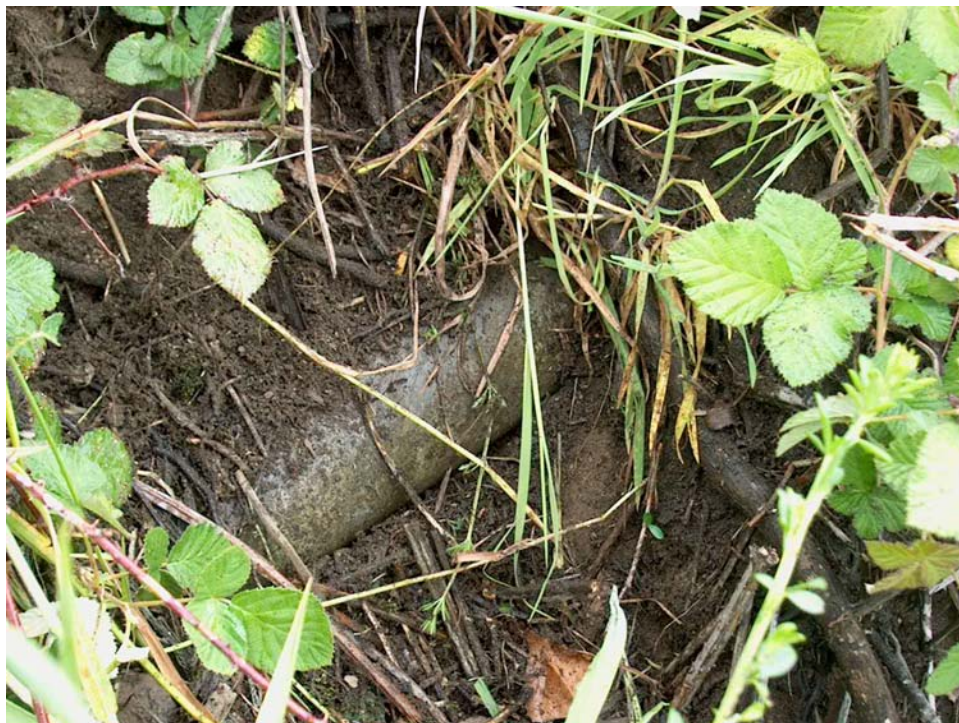
Vicinity of potential outfall WR-190; buried pipe filled with soil.

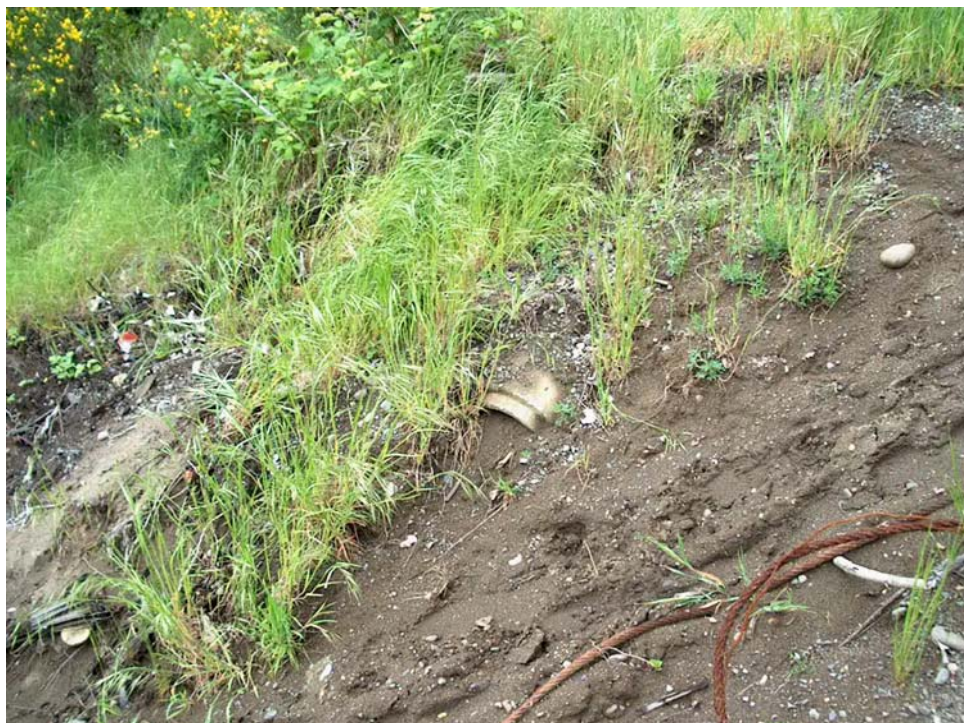
Vicinity of potential outfall WR-190; buried pipe filled with soil.

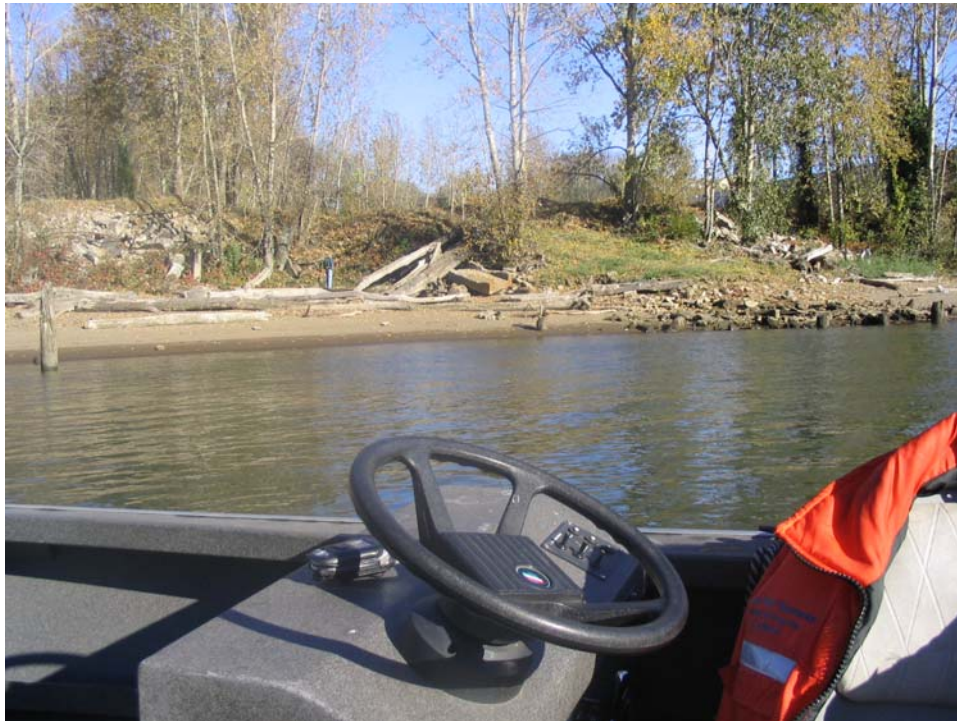
Vicinity of reported outfall WR-193; Outfall not found.

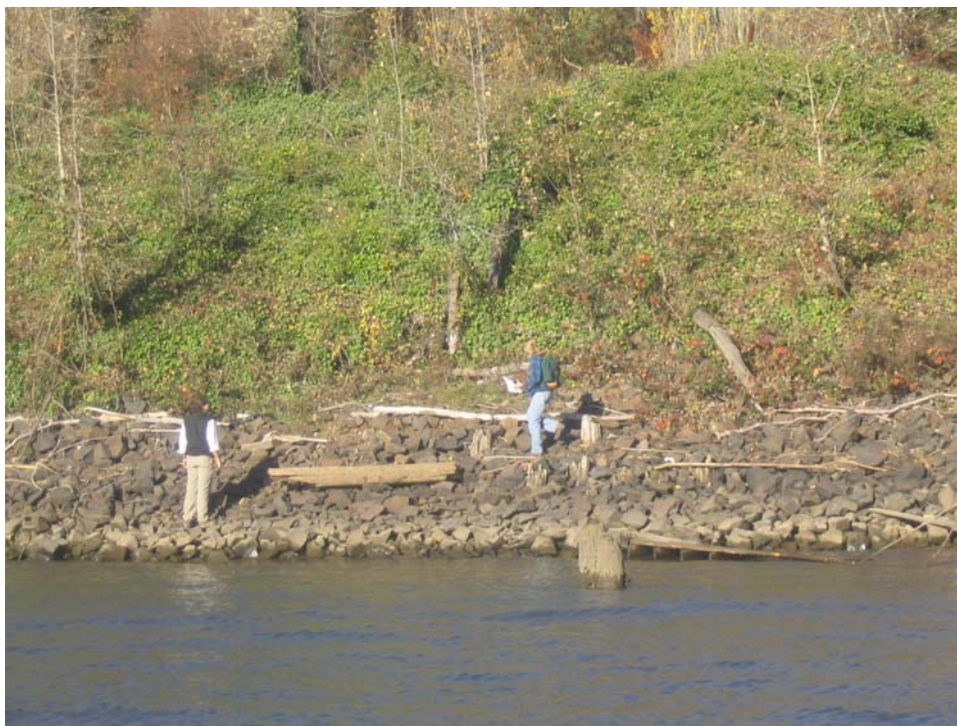
Vicinity of reported outfall WR-192; Outfall not found.

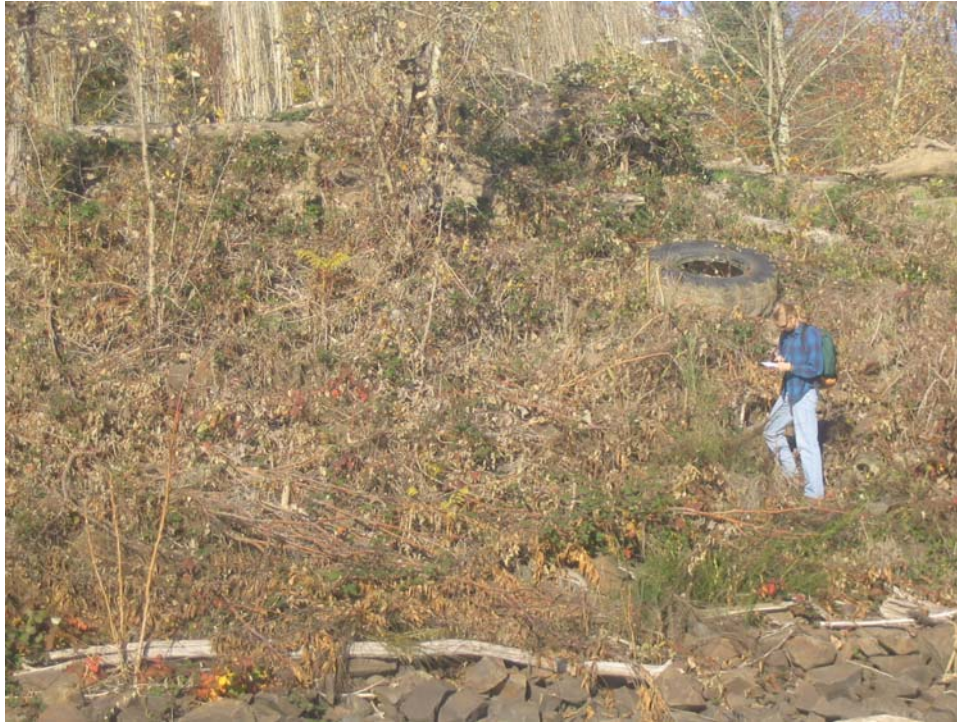
Vicinity of reported outfall WR-191; Outfall not found.

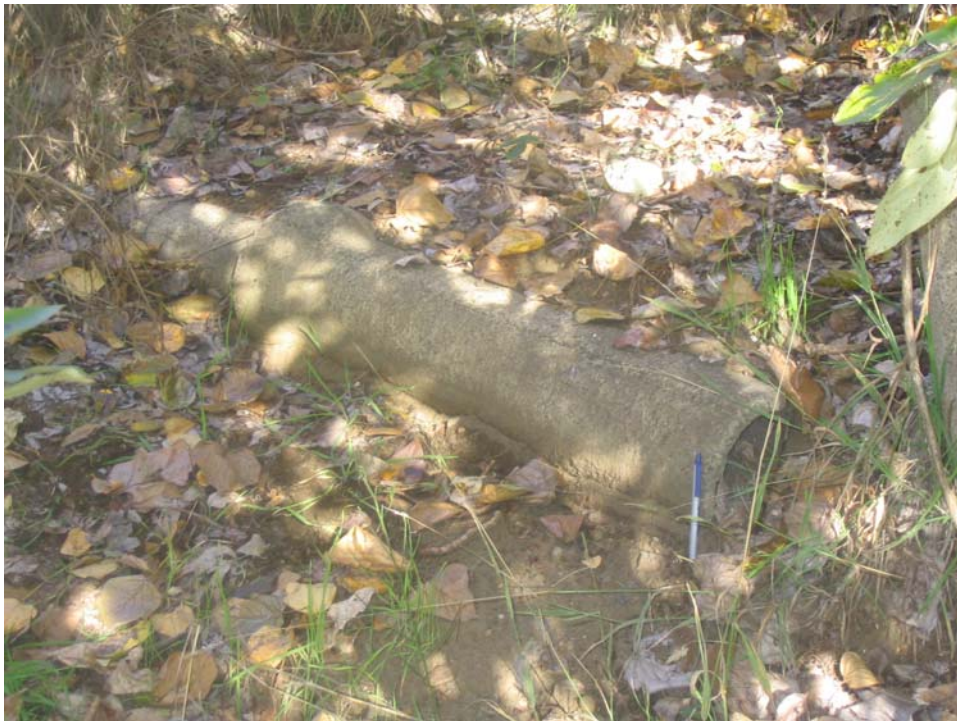
In the vicinity of reported outfall WR-190, the 6-inch diameter concrete pipe filled with soil was located and photographed (see Figure 4). As previously observed, the pipe appeared to be filled with soil and no evidence of water drainage was seen. At the time of observation, the end of the pipe was approximately 20 to 25 feet from the water's edge and additional pieces of the jointed concrete pipe were found on the beach closer to the river. It appears that the end of the pipe is above typical high water levels.

Vicinity of reported outfall WR-190; buried pipe filled with soil.

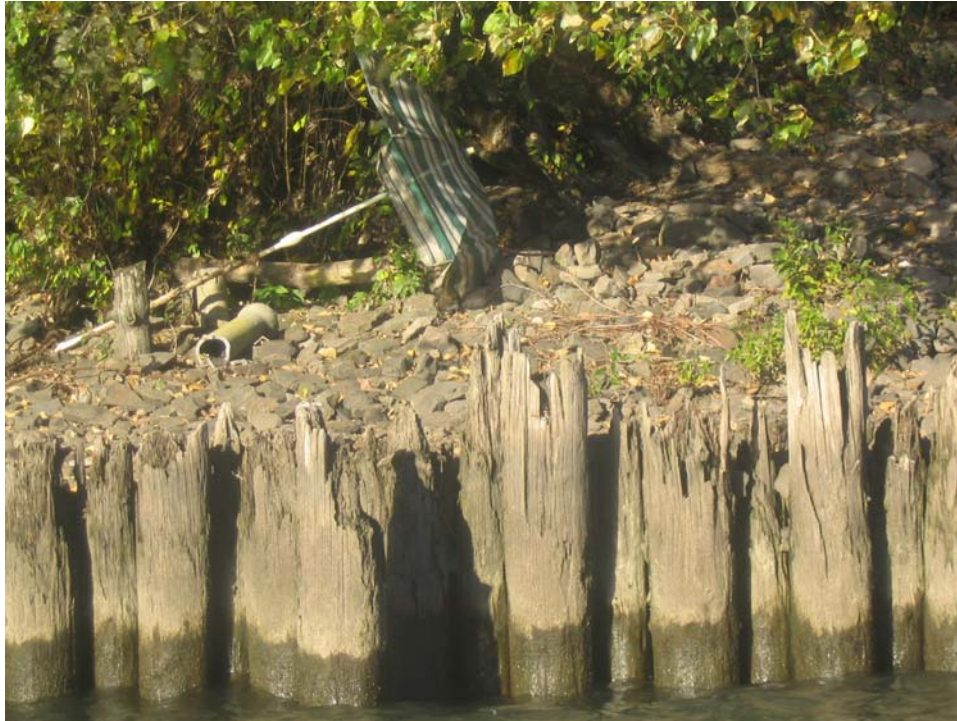
Possible pieces of concrete pipe in vicinity of WR-190 on beach.

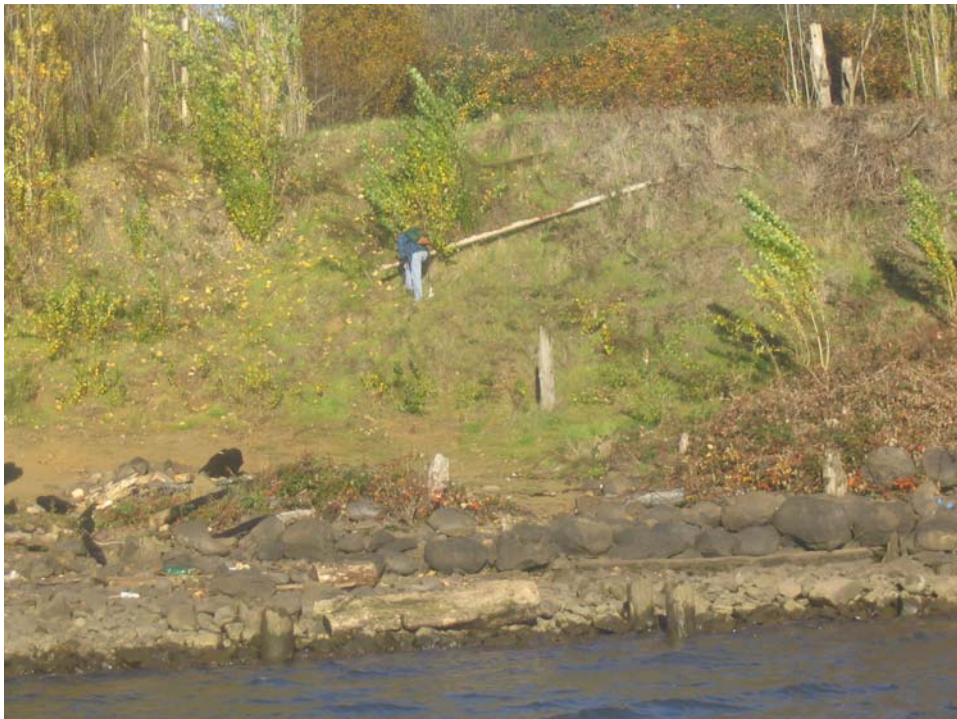
Six-inch diameter pipe; likely a steam line from former boiler.
Not in a reported outfall location.

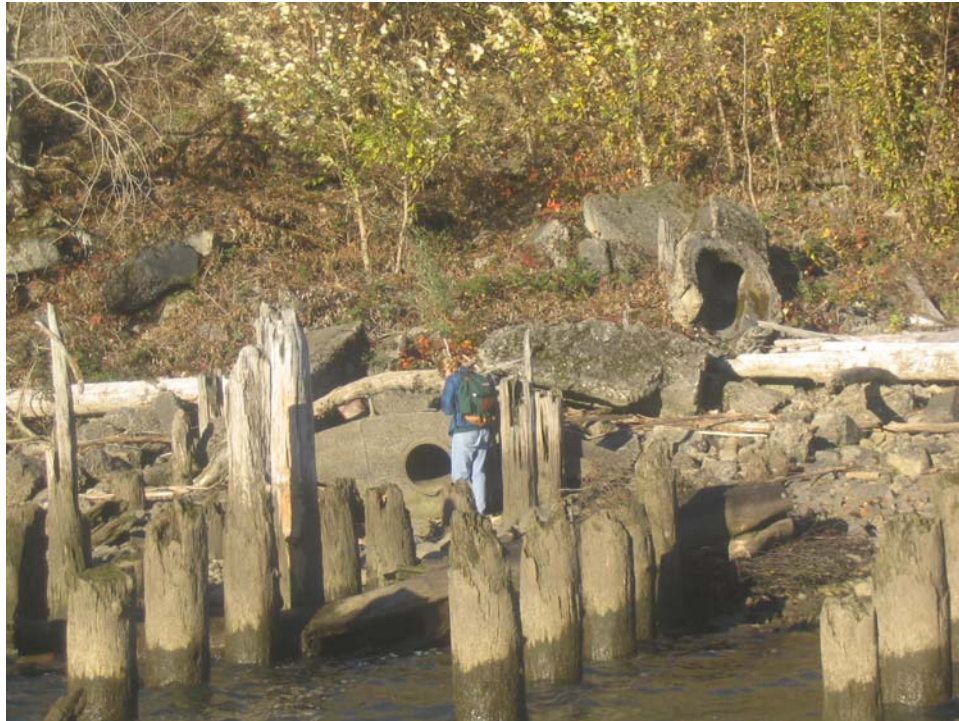
Outfall OF49

The City's active outfall (OF-49) was located and photographed (Figure 4). This outfall is a jointed concrete pipe, with an inside diameter of approximately 15 inches. There were large rocks and concrete rubble near the end of the outfall. At the time of observation, the end of the pipe was approximately 10 feet from the water's edge (where it had been observed to be partially to almost fully submerged during the previous site visits; see Figure 2 and 3). No water was observed to be draining from the outfall during the field team's reconnaissance.

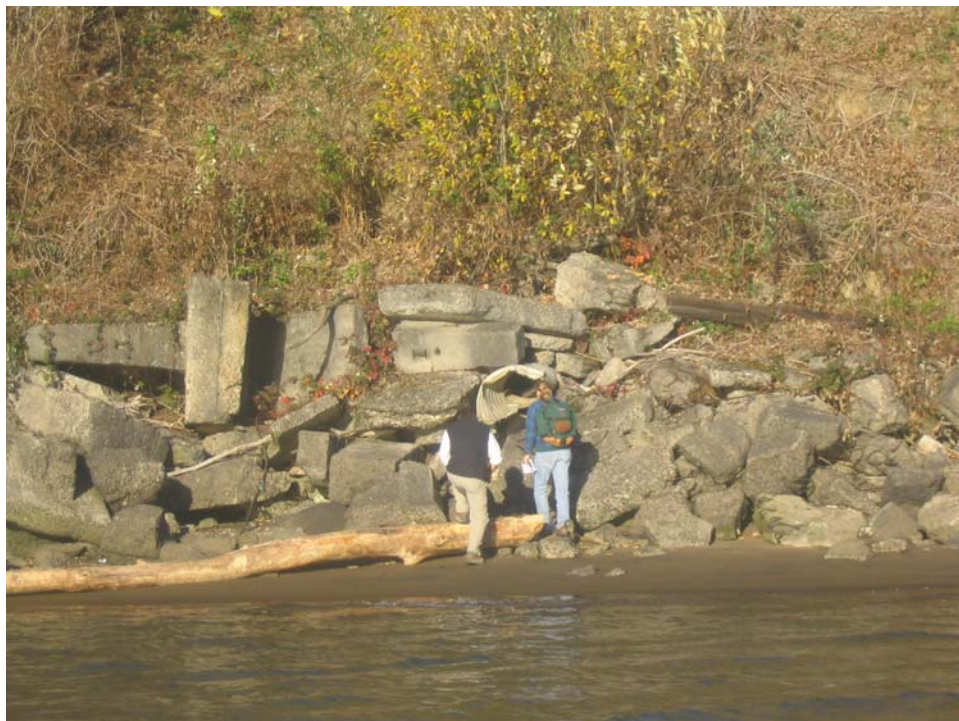
The two-foot diameter corrugated steel pipe at location of the reported outfall WR-189 was located and photographed. At the time of observation, the end of the pipe was approximately 10 feet from the water's edge (the mouth of the pipe was at the water's edge during the May 2005 visits; Figure 4). The pipe had an inch or so of rock and soil in the bottom of it and no evidence of water drainage was seen. Consistent with the May 2005 visits, the 2-foot diameter pipe did not appear to be an active outfall.

Two-foot diameter corrugated steel pipe at reported location for potential outfall WR-189. Did not appear to be an active outfall.

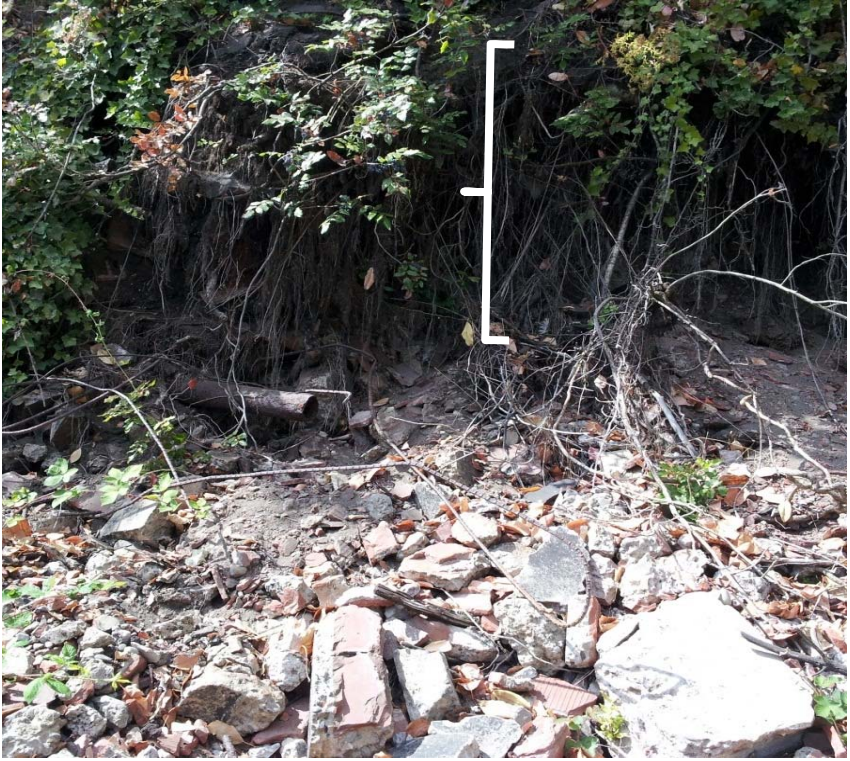
Photo No: 1

- An approximately 5-inch-diameter steel pipe was observed in an oversteepened riverbank on the northern portion of the Inner Cove Beach on the East Parcel (Photograph 1; Attachment B). The pipe was oriented nearly parallel to the riverbank and appeared to be mixed with other debris (e.g., bricks, clay tile, etc.) in the riverbank. Consequently, this pipe is considered debris and does not constitute a current or historical discharge pipe from the Facility. No additional observations of this pipe were completed due to the oversteepened condition of the riverbank.

Photo Date: 8/8/2012	
Orientation: North	
Description: 5-inch steel pipe debris observed in oversteepened riverbank on the northern portion of the Inner Cove Beach on the East Parcel. Note the debris (e.g., bricks, clay tile, concrete) in the foreground. White bracket highlights approximately 5 feet of oversteepened riverbank.

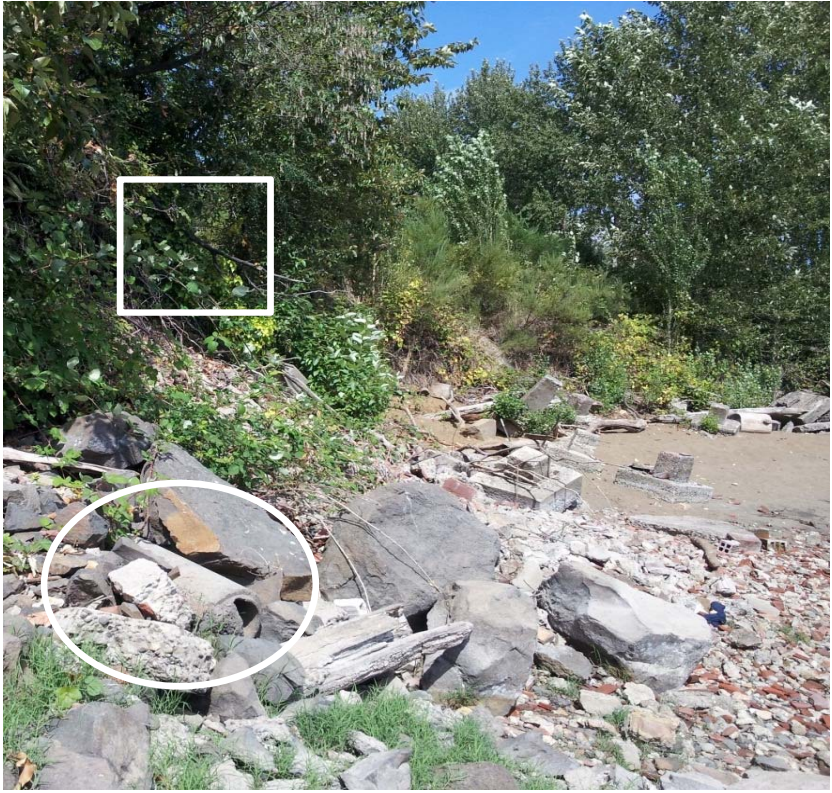
Photo No: 2

- A section of concrete pipe with a 6-inch inner diameter was observed on the riverbank on the northern portion of the Inner Cove Beach on the East Parcel (Photographs 2 and 3). Rip-rap rock removed from the riverbank side of the pipe confirmed that this pipe section was not connected to the riverbank. Consequently, this pipe is considered debris and does not constitute a current or historical discharge pipe from the Facility.

Photo Date: 8/8/2012	
Orientation: Northeast	
Description: The white oval highlights a section of concrete pipe observed on the riverbank on the northern portion of the Inner Cove Beach on the East Parcel. The white square shows approximate the location of the pipe section shown in Photograph 1.

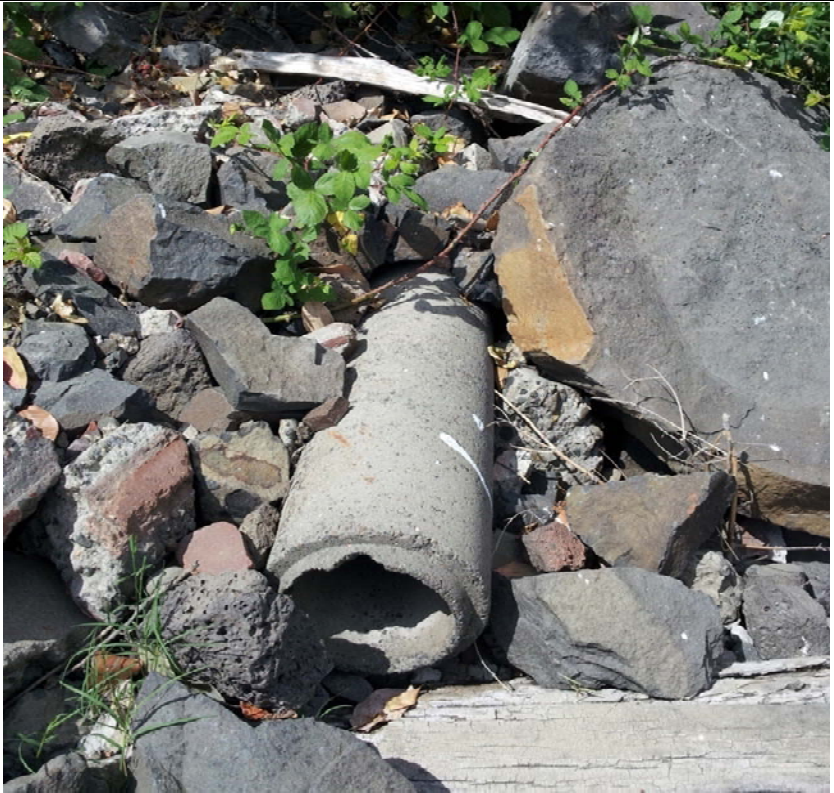
Photo No: 3

Photo Date: 8/8/2012	
Orientation: Northeast	
Description: Rip-rap rock removed from the riverbank side of the concrete pipe confirmed that this pipe section was not connected to the riverbank.	
Photo No: 4

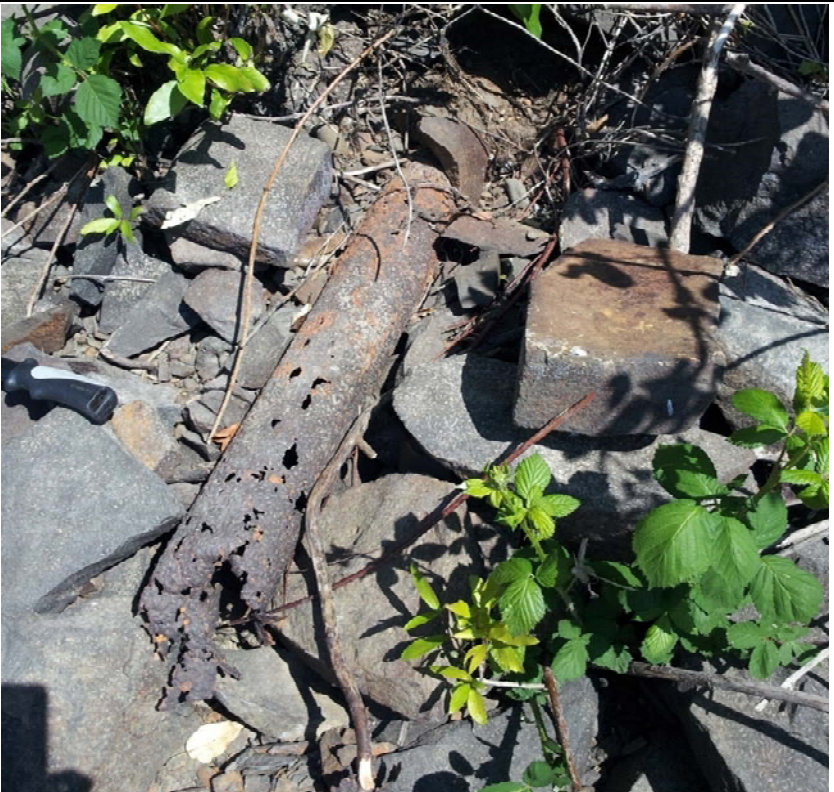
- A 5-inch-diameter steel pipe was observed in the riverbank adjacent to historical riverbank sample location WC-SSP-1 on the Central Parcel Photograph 4 and Figure 2. This pipe is located in the vicinity of the outfall previously designated by the City as WR-192. A tape measure was inserted into the pipe to a length of 28 feet (approximately 25 feet into the riverbank) before it met a blockage. Consequently, this pipe is considered to be in place. There was no evidence that this pipe is still active.

The 5-inch steel pipe observed in the riverbank in the vicinity of location WR-192 is considered to be in place but does not appear to be active.

Historical composite samples were collected from locations WC-SSP-1 and WC-SSP-3 (no sampleable soil was identified at location WC-SSP-2) at two depths (shallow – 0-6 inches and deep – 24-30 inches). Concentrations of metals and polycyclic aromatic hydrocarbons (PAHs) were detected in the shallow and deep samples at concentrations elevated relative to the Joint Source Control Strategy (JSCS) screening criteria (DEQ/EPA 2005). Follow-up analyses of the discrete samples from WC-SSP-1 and WC-SSP-3 indicated that higher relative concentrations of metals and PAHs were attributed to location WC-SSP-1. Location WC-SSP-1 is located approximately 10 feet from the observed riverbank pipe.

Photo Date: 8/6/2012	
Orientation: North	
Description: 5-inch steel pipe embedded in the riverbank adjacent to historical riverbank sample location WC-SSP-1.

The only new information on upland pipes associated with the uplands is the uncovering of the pipes in the vicinity of WR-191 and WR-192 (Photographs 4 and 5; Figure 2). Sufficient laboratory analytical data are already available to complete the evaluation of the historical pipe in the vicinity of WR-192. This evaluation will be completed as part of the Source Control Evaluation (SCE) for the Facility.

The Port will also confirm that the WR-191 and WR-192 are inactive during the upcoming wet season and document these findings in the SCE.

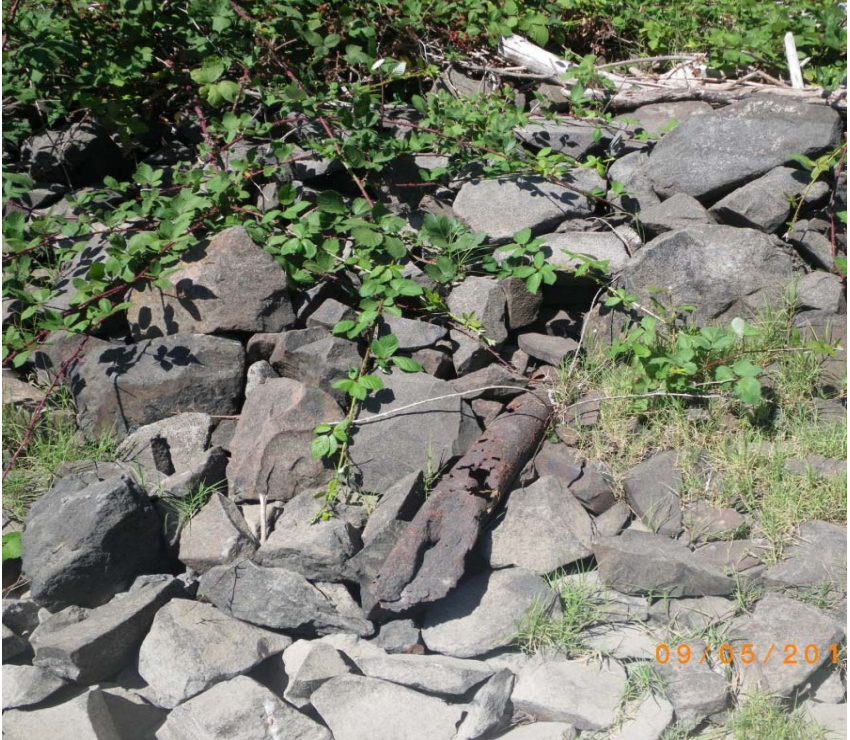
- A 5-inch-diameter steel pipe was observed in the riverbank adjacent to historical riverbank sample location WC-SSQ-1 (Photograph 5). This pipe is located in the vicinity of the outfall previously designated by the City as WR-191. A tape measure was inserted into the pipe to a length of 8 feet (approximately 5 feet into the riverbank) before it met a blockage. Consequently, this pipe is considered to be in place. There was no evidence that this pipe is still active.

The 5-inch steel pipe observed in the riverbank in the vicinity of location WR-191 is considered to be in-place but does not appear to be active. A historical composite sample was collected from location WC-SSQ but at a higher elevation than the observed riverbank pipe.

<p>Photo Date: 9/4/2012</p>	
<p>Orientation: Northwest</p>	
<p>Description:</p> <p>5-inch steel pipe embedded in the riverbank adjacent to historical riverbank sample location WC-SSQ.</p>	
<p>Photo No: 6</p>

The Port proposes to collect a soil sample below the pipe in the vicinity of location WR-191. The sample will be submitted for the following analyses.

- Metals by EPA 6000/7000 Series Methods;
- PAHs by EPA Method 8270-SIM; and
- Polychlorinated biphenyls (PCBs) by EPA Method 8082.

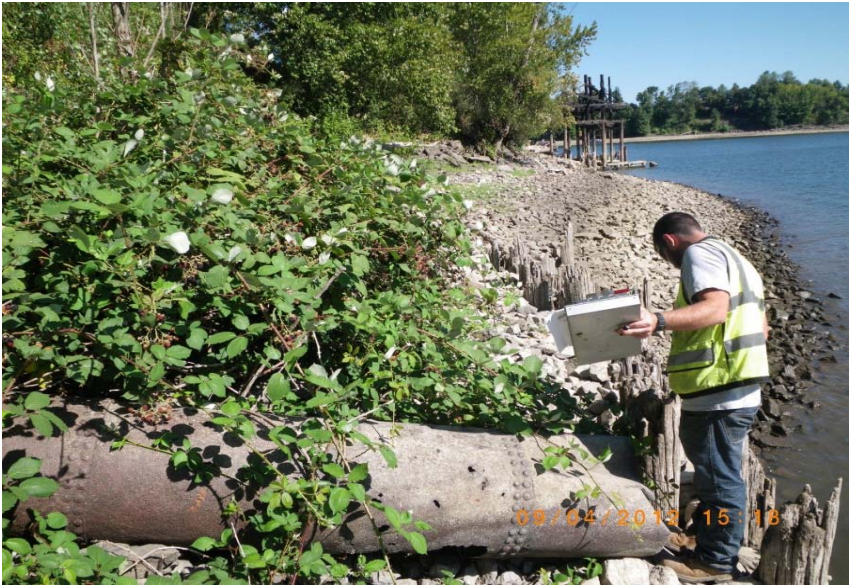
- A concrete/masonry-lined metal sleeve was observed in the vicinity of historical riverbank sample location WC-SSS (Photograph 6). This is the same pipe segment that was observed in 2005. This pipe is considered debris and does not constitute a current or historical discharge pipe from the Facility.
- A 4-inch pipe was observed on the southern portion of the Central Parcel beach (Photograph 7). This is the same pipe that was observed in 2005 and reported in the 2006 memorandum to be a steam line from a former boiler that used to be located on the Facility.
- An approximately 5-inch hole was observed in the riverbank on the northern portion of the Central Parcel beach (Photograph 8). A tape measure was inserted into the hole to a length of 1.5 feet before it met a blockage. No pipe was observed associated with this hole. The hole appears to be an animal burrow.

<p>Photo Date: 9/4/2012</p>	
<p>Orientation: Southwest</p>	
<p>Description:</p> <p>Concrete/masonry-lined metal sleeve was observed in the vicinity of historical riverbank sample location WC-SSS. This is the same pipe segment that was observed in 2005.</p>

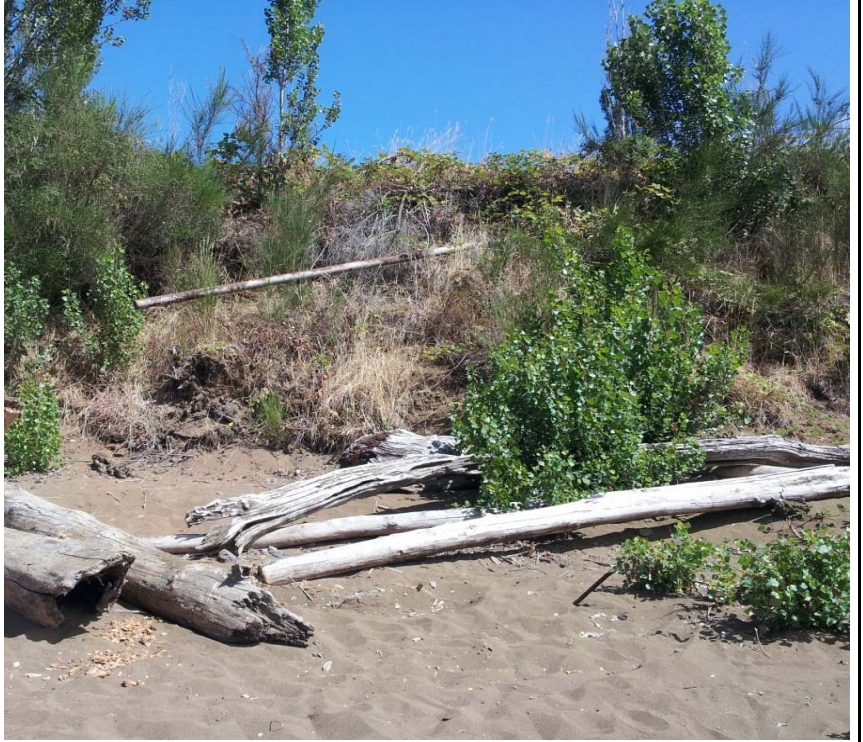
Photo Date: 8/22/2012	
Orientation: Northeast	
Description: 4-inch pipe observed on the southern portion of the Central Parcel beach. This is the same pipe that was observed in 2005 and reported to be a steam line from a former boiler located on the Facility.	
Photo No: 8

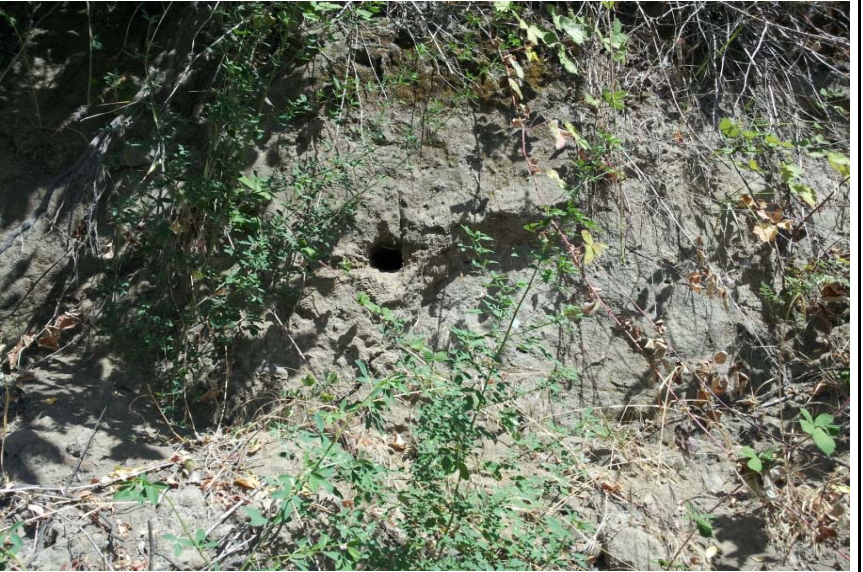
Photo Date: 8/22/2012	
Orientation: Northeast	
Description: 5-inch hole observed in the riverbank on the northern portion of the Central Parcel beach. No pipe was observed associated with this hole. The hole appears to be an animal burrow.
